WADDEN SEA ISLANDS (THE NETHERLANDS)

1. GENERAL DESCRIPTION OF THE AREA

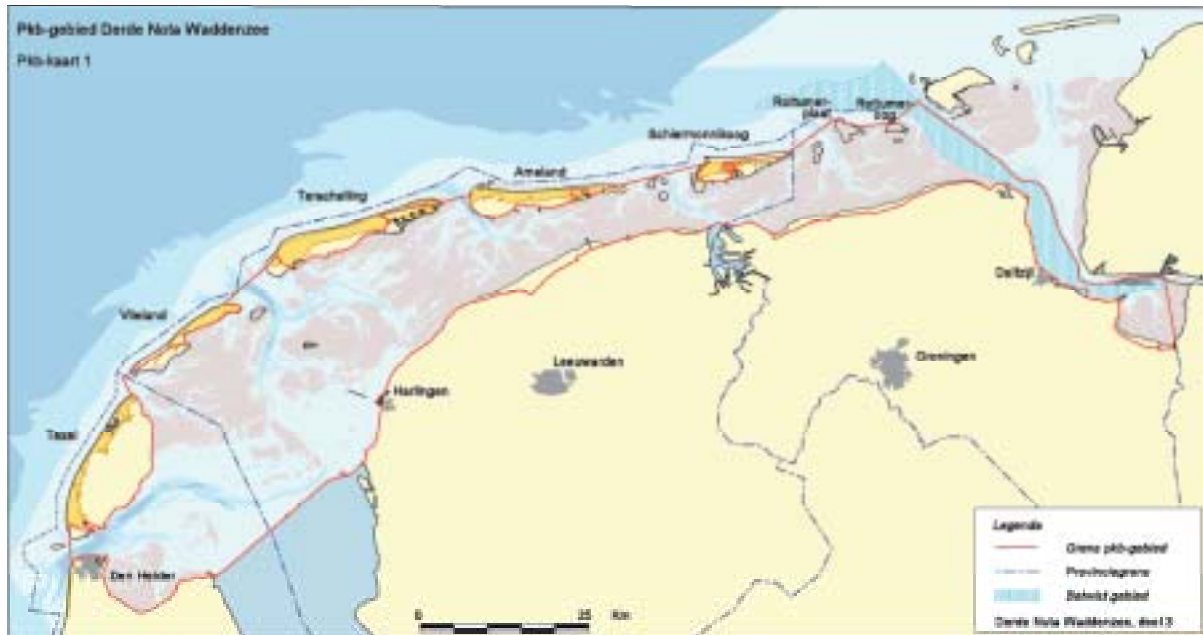
Fig. 1: Map of the Wadden Sea and islands (VRM, 2001).

In the Wadden Sea the spring tidal range is about 2 m and this keeps a complex system of tidal channel and flats intact, see Figure 1. Along the main land in some areas salt marshes are present.

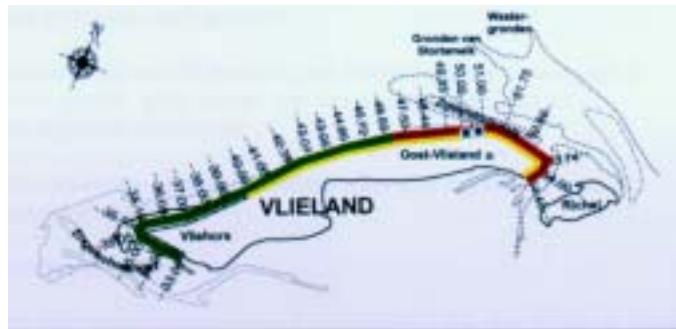
Fig. 6: Vlieland erosion and sedimentation.

The NE upper one third of the North Sea side is eroding. The tidal channel at the East side of the island is moving landwards.

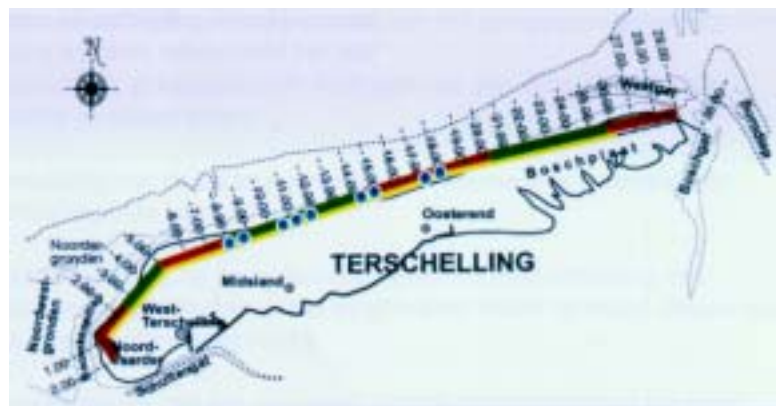
Fig. 7: Terschelling erosion and sedimentation.

The middle part of the North Sea side beach is eroding and the East side head of the island shows rapidly cyclic behaviour.

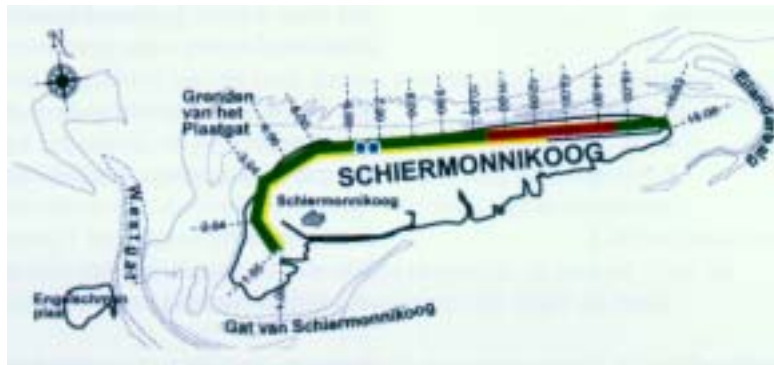
Fig. 9: Schiermonnikoog erosion and sedimentation.

This island is stable. Erosion not significant.

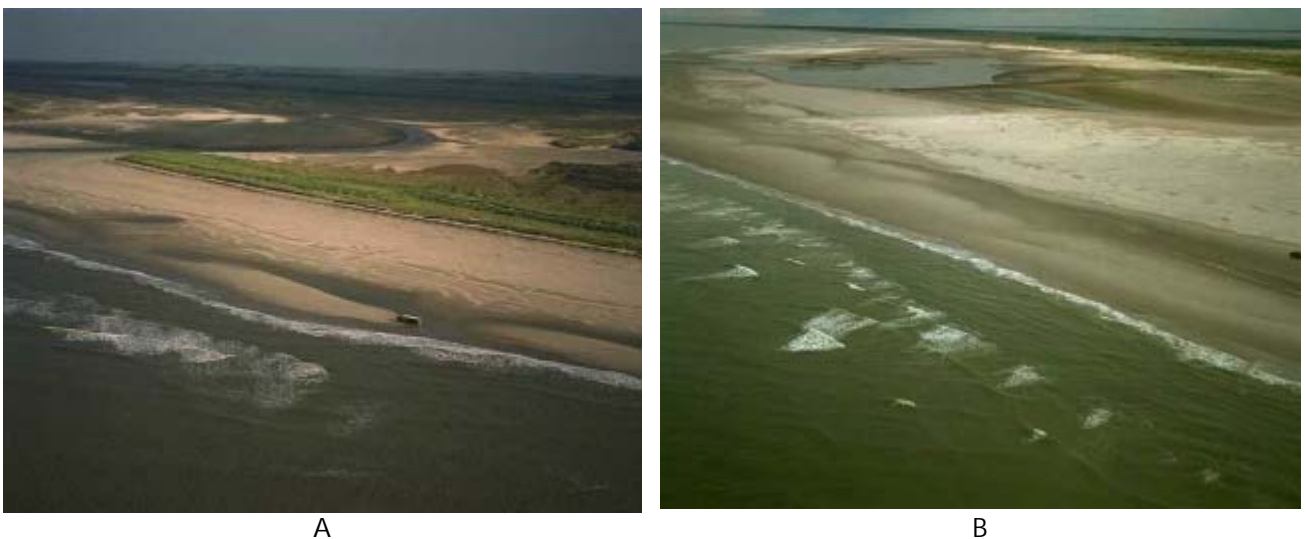
Fig. 10: Photos of Slufter at Texel (A) and salt marsh at Ameland (B) (source: Archive, RIKZ).

Erosion along the North Sea side coast causes a higher risk for flooding. First, erosion is a threat for nature areas: dunes and salt marshes. At Texel this is the 'Slufter', this is a tidal inlet, see Figure 10a. Also, a salt marsh is eroding at Texel. At Ameland at the SW side a salt marsh is eroding, see Figure 10b. Generally seen as more important, if dunes disappear, urban areas are being threat.

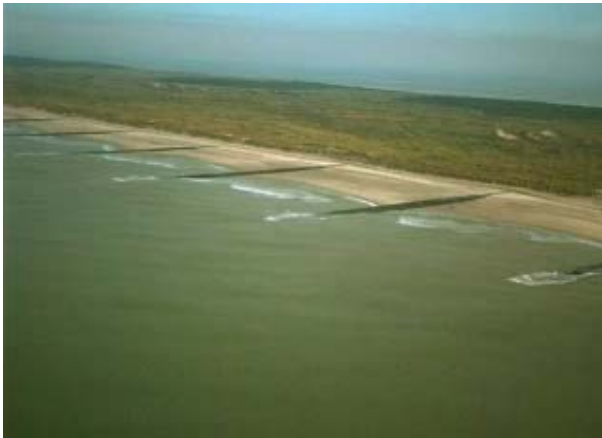
A. Groynes at Vlieland

Texel	groynes	1950-1986
	cross-shore dam "Eijerlandse gat dam"	1990
	2 places at channels: revetments	before 1940
Vlieland	groynes, see Figure 11a	1870-2000
Ameland	revetments at channel	1948-1990

Fig. 11: Photos of hard(A) and soft(B) measures.

For Vlieland, a mixed option was chosen. Research of local coastal dynamics resulted in removal of existing groynes and construction of two new ones together with a beach nourishment of 200.000m³. Dams have a length of 200m and 180m. Building cost of the two dams were eventually 2.6M€.

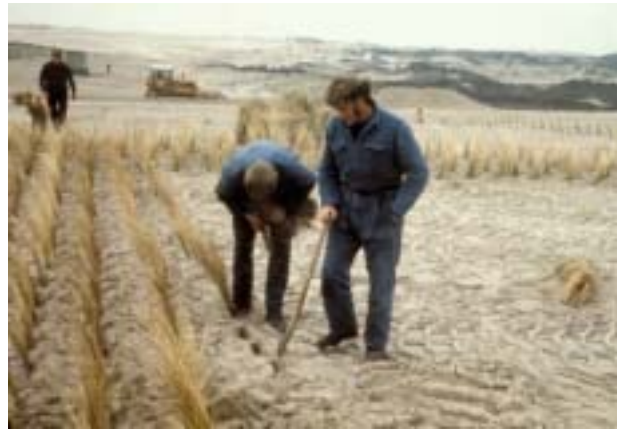
B. Planting of maram grass

For many years dune maintenance has been carried out existing of leveling of dunes and maram grass planting, see Figure 11b.

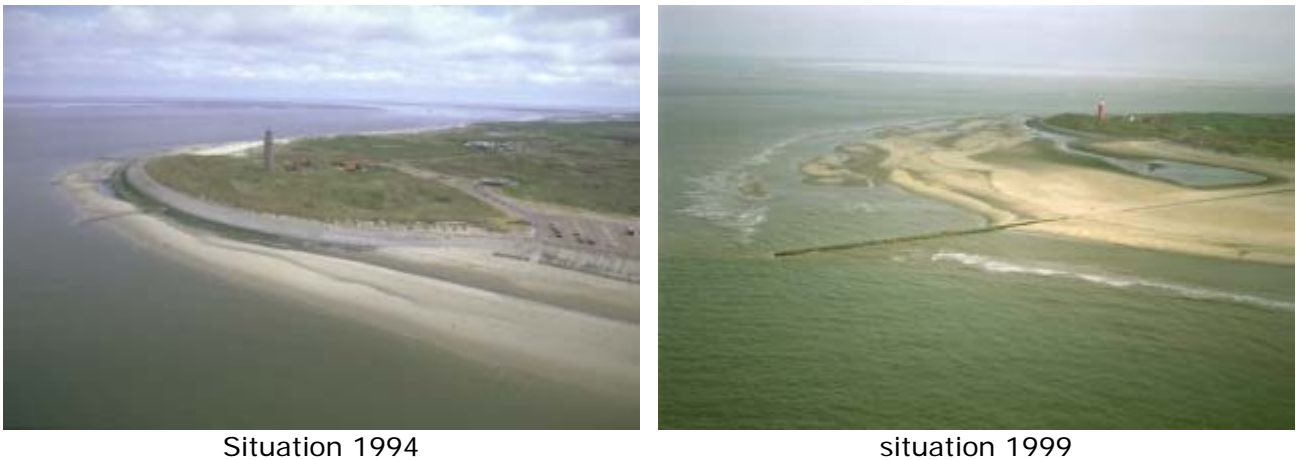
Fig. 12: Effect cross-shore dam at island Texel.

At Texel between 1979 and 1995 14.8Mm³ has been nourished. This is less than the total erosion of 15.8 Mm³. The effect of the cross-shore dam is currently (2002) still under discussion. It is very clear that since construction strong accretion took place. The striking result is that the accretion takes place at both sides of the dam. The original purpose was accretion at the SW side of it, see Figure 12.

For the NW side of the island Texel a combined measure was chosen of hard and soft solutions. The dam has a total length of 800m with 550m seawards from the coastline. First in 1994, a volume of 2Mm³ was nourished on the beach. Then in 1995, the dam was constructed in 4 months. Building costs of the dam were eventually 8M€.
